| APPENDIX A-3:ANNUAL UNDERGROUND STORAGE SYSTEM INSPECTION CHECKLIST | | | | | | | | | | | | | |
| 10551 | Marycrest Marathon | | | | | | | | | | | | |
| | 2322 West Western Avenue | | | | | | | | | | | | |
| | South Bend, IN 46619 | | | | | | | | | | | | |

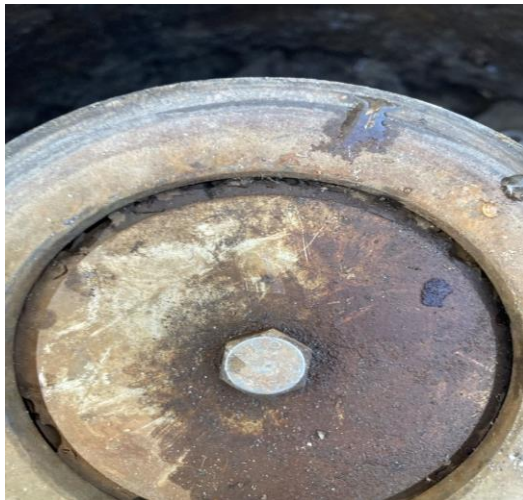
VAPOR RECOVER ADAPTER NEEDS REPLACED ON PUL TANK - DAMAGED

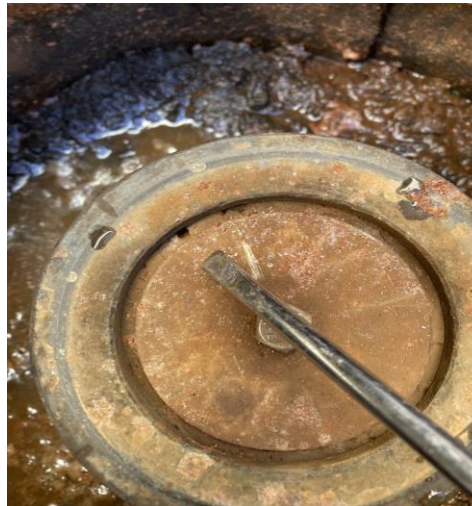
VAPOR RECOVER ADAPTER NEEDS REPLACED ON RUL MAIN TANK

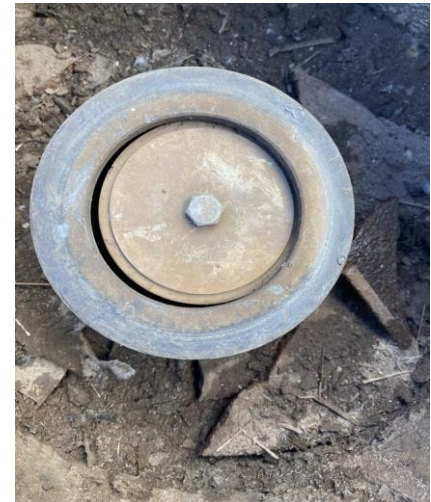
VAPOR RECOVER ADAPTER NEEDS REPLACED ON RUL SLAVE TANK
