# A&J PETROLEUM

**FID 16625**  
**8498 S US HWY 6**  
**Hamlet, IN**

## **Piping Layout and Interstitial Monitoring**

## ATG Functionality Test Results

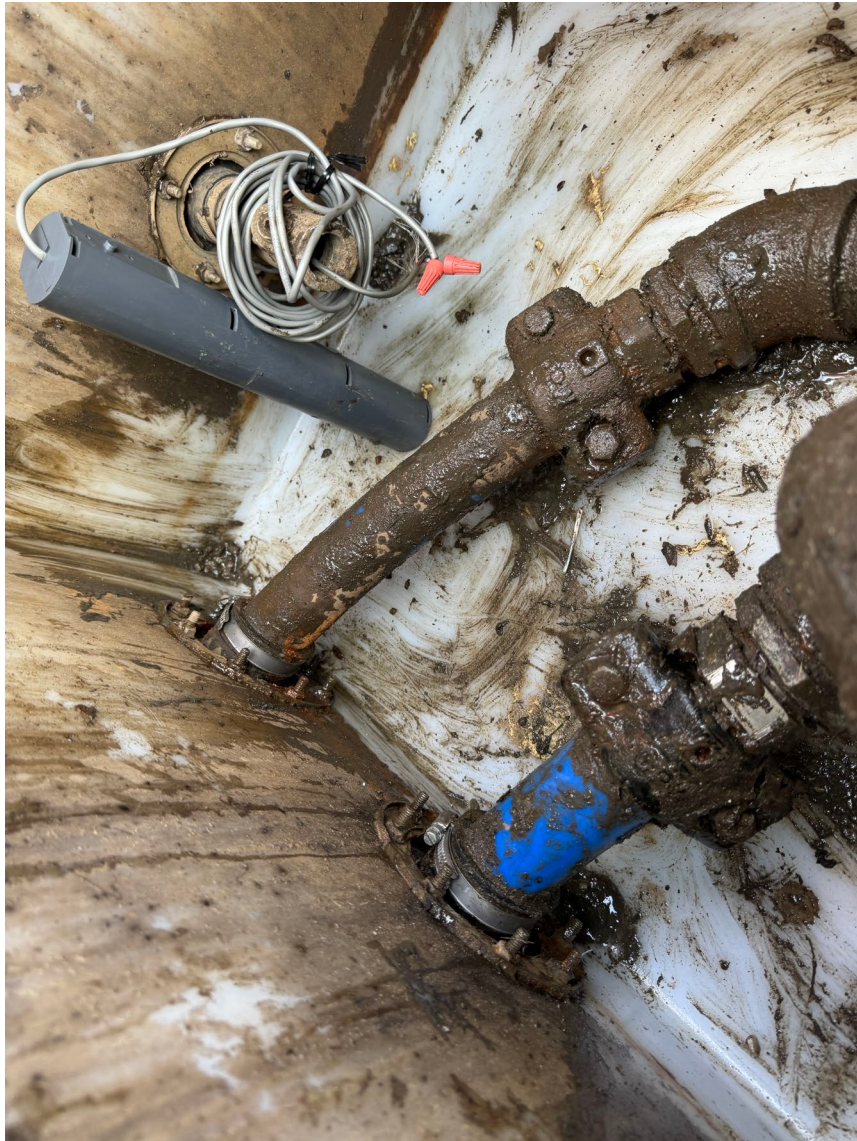
## UNLEADED AND PREMIUM TRANSITION SUMP

Unleaded and Premium utilize a below grade transition sump with a sensor positioned at the lowest point of the sump.

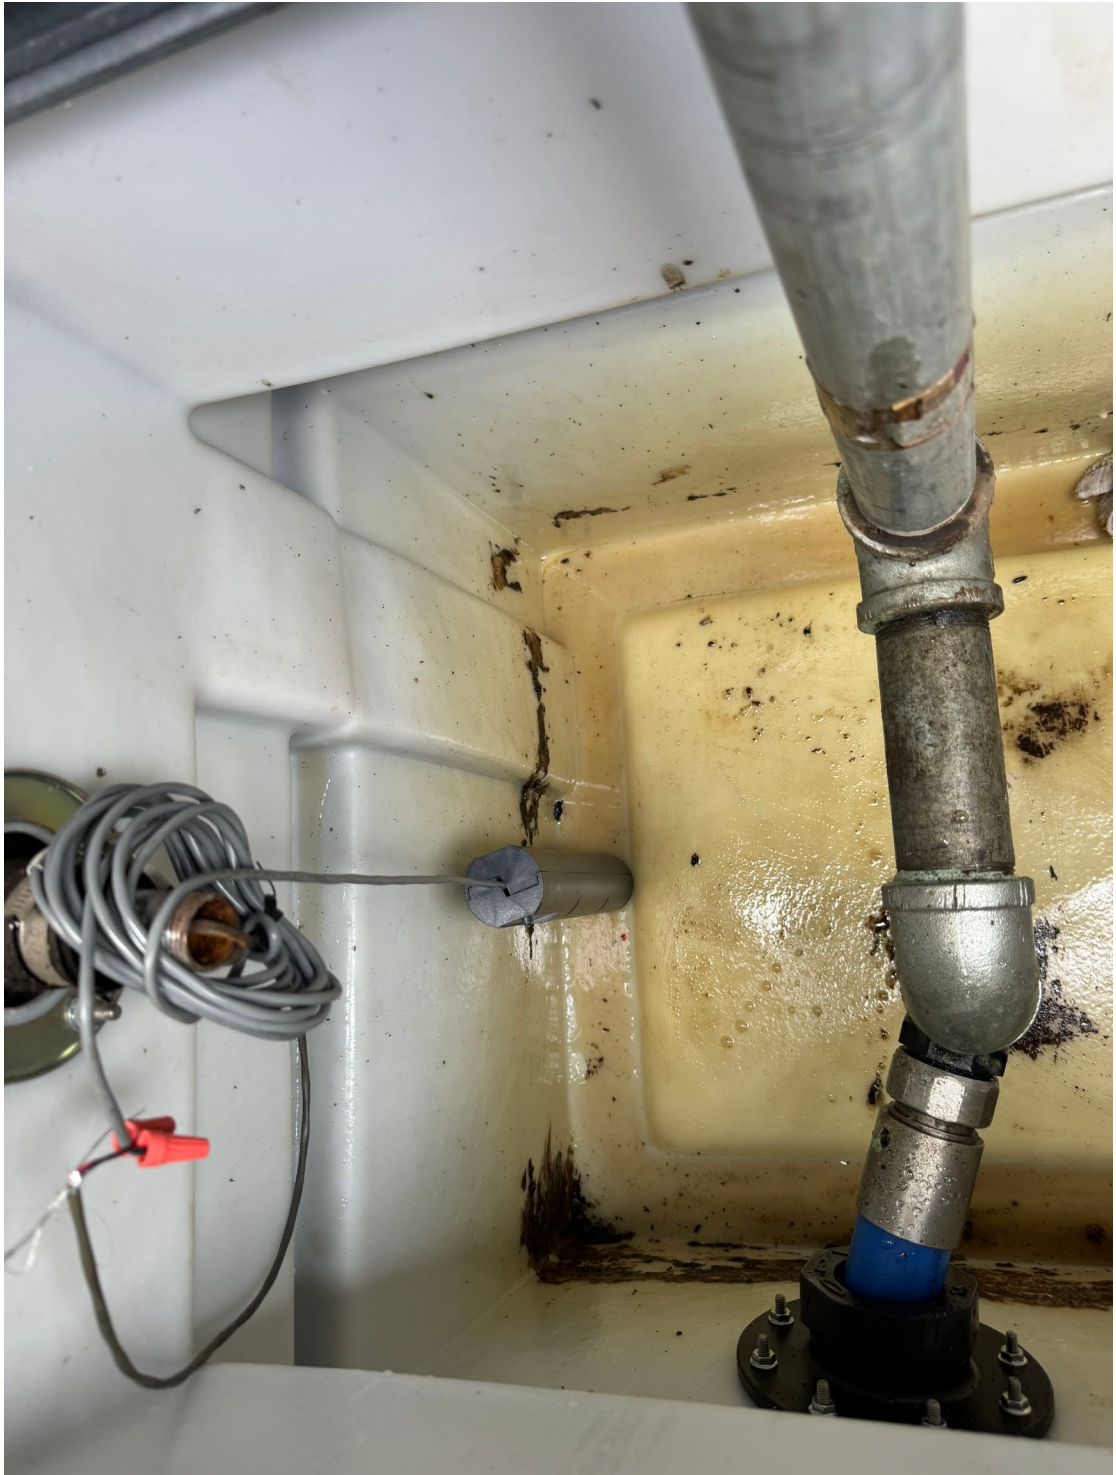
## DIESEL TRANSITION SUMP

Diesel is an AST (aboveground storage tank) and utilizes a transition sump with sensor to transition to the below grade piping.
