# Armor Shield

## INSPECTION AFFIDAVIT-FORM BF2

Site Marathon - Colfax Property  
831 E. Colfax Avenue  
South Bend, IN 46617

Tank ID # (1) 6,000 Gallon  
Facility ID # 15294  
Lining Date  
5 yr. Inspection ☒

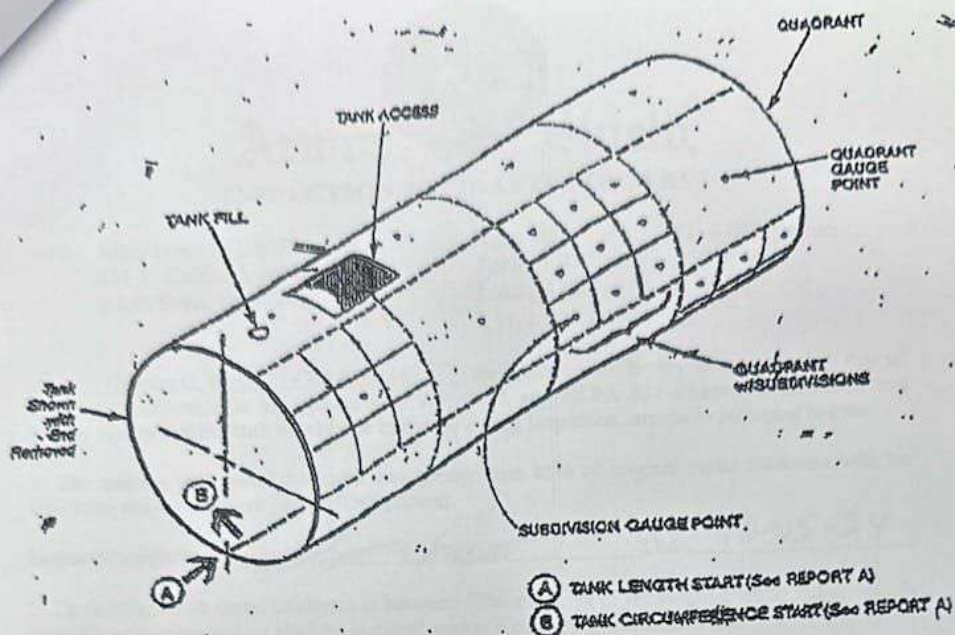
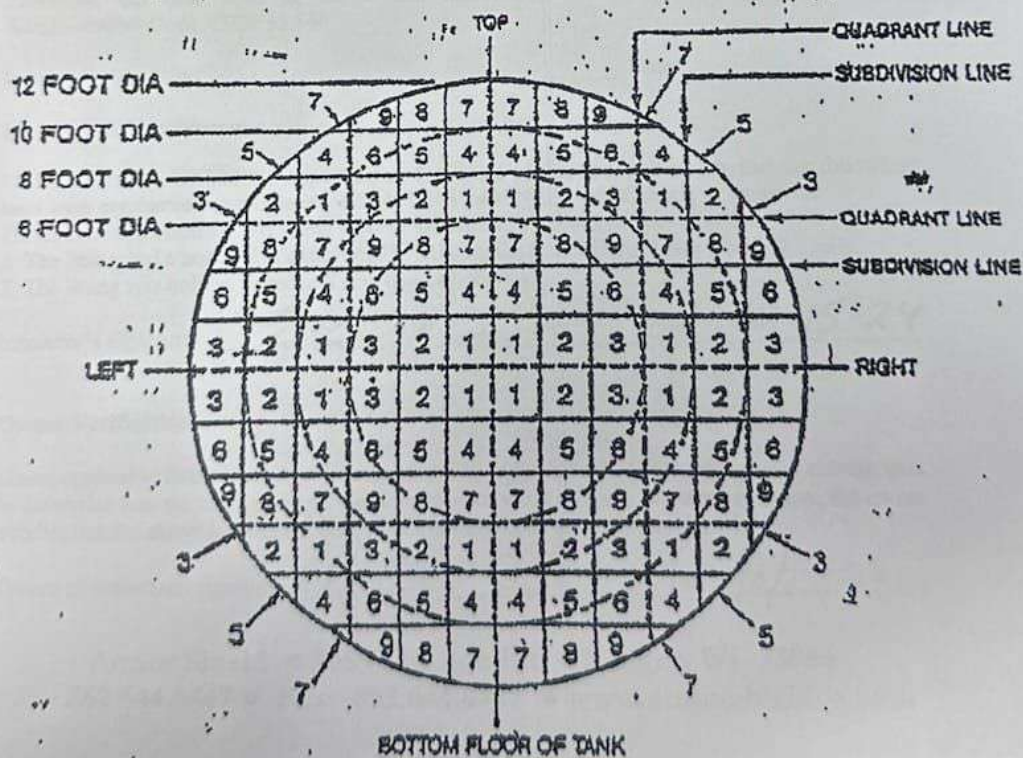
| Total Tank Shell Average | |
|---|---|
| Design Thk. | 97 % of Design Thk. |

| Tank Diameter | 8 | Tank Length | 16 |

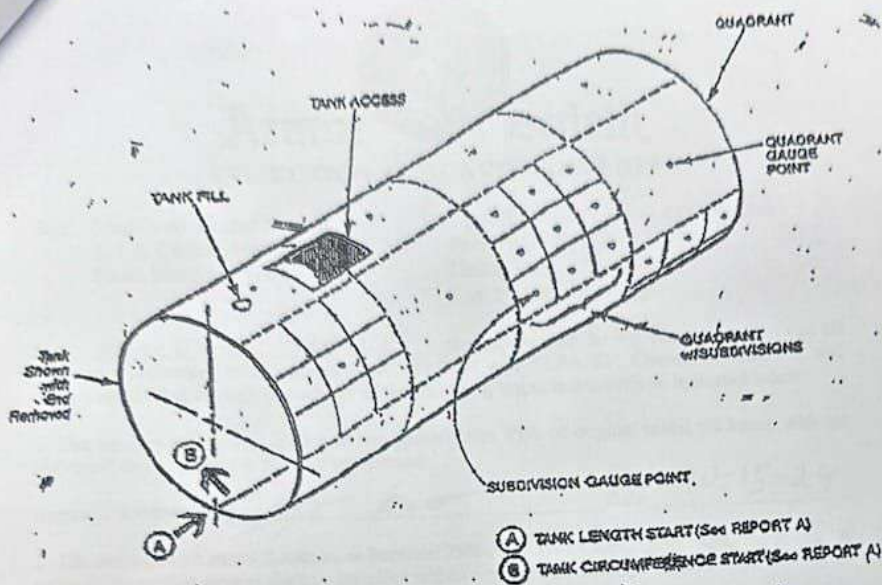
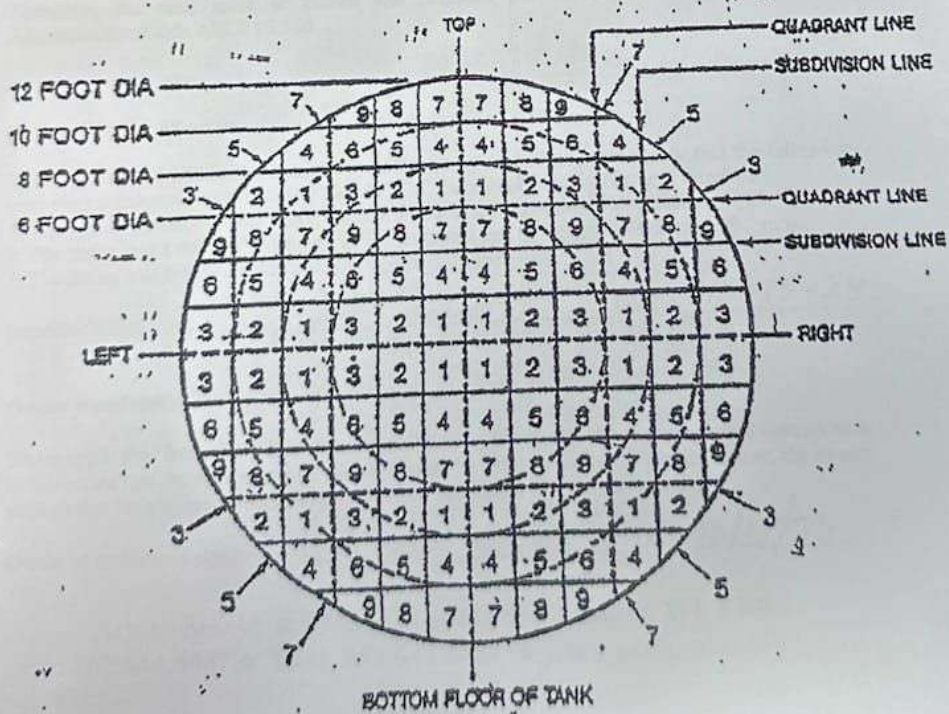
4. Total of Gauges 180 Av. Thk.  
Total No. of Gauges  
Av Thk 95 x 100 % of Design  
Design Thk. Thk

| Tank Diameter | 64" | Tank Length | 24 |

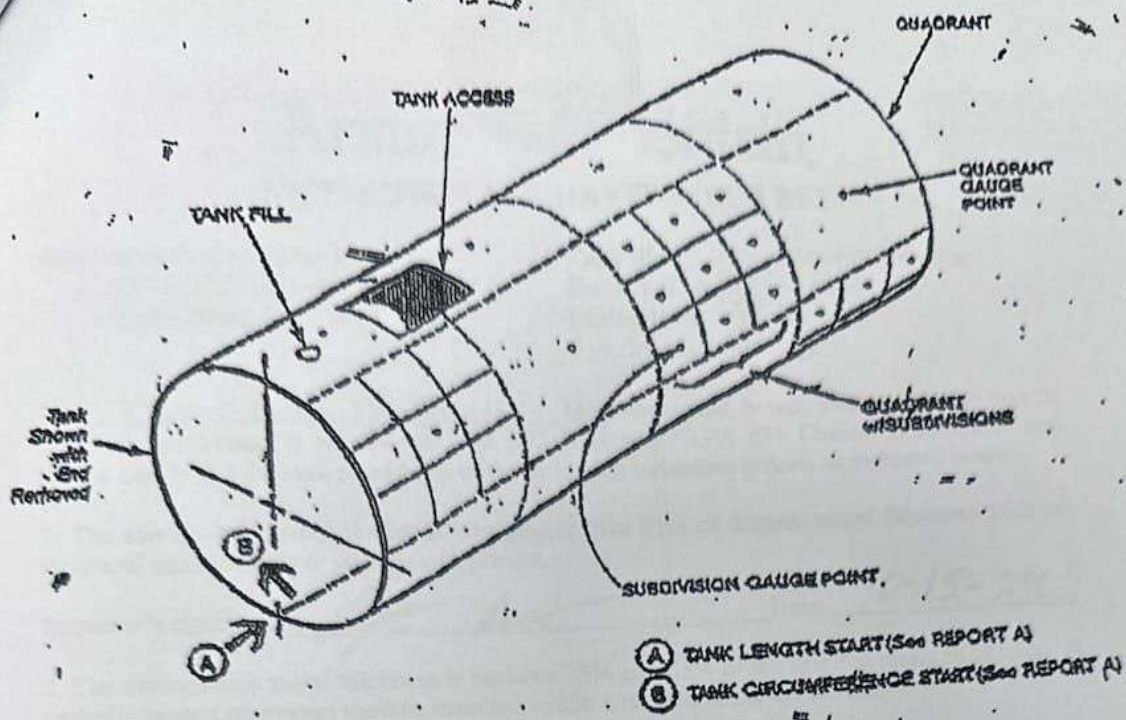
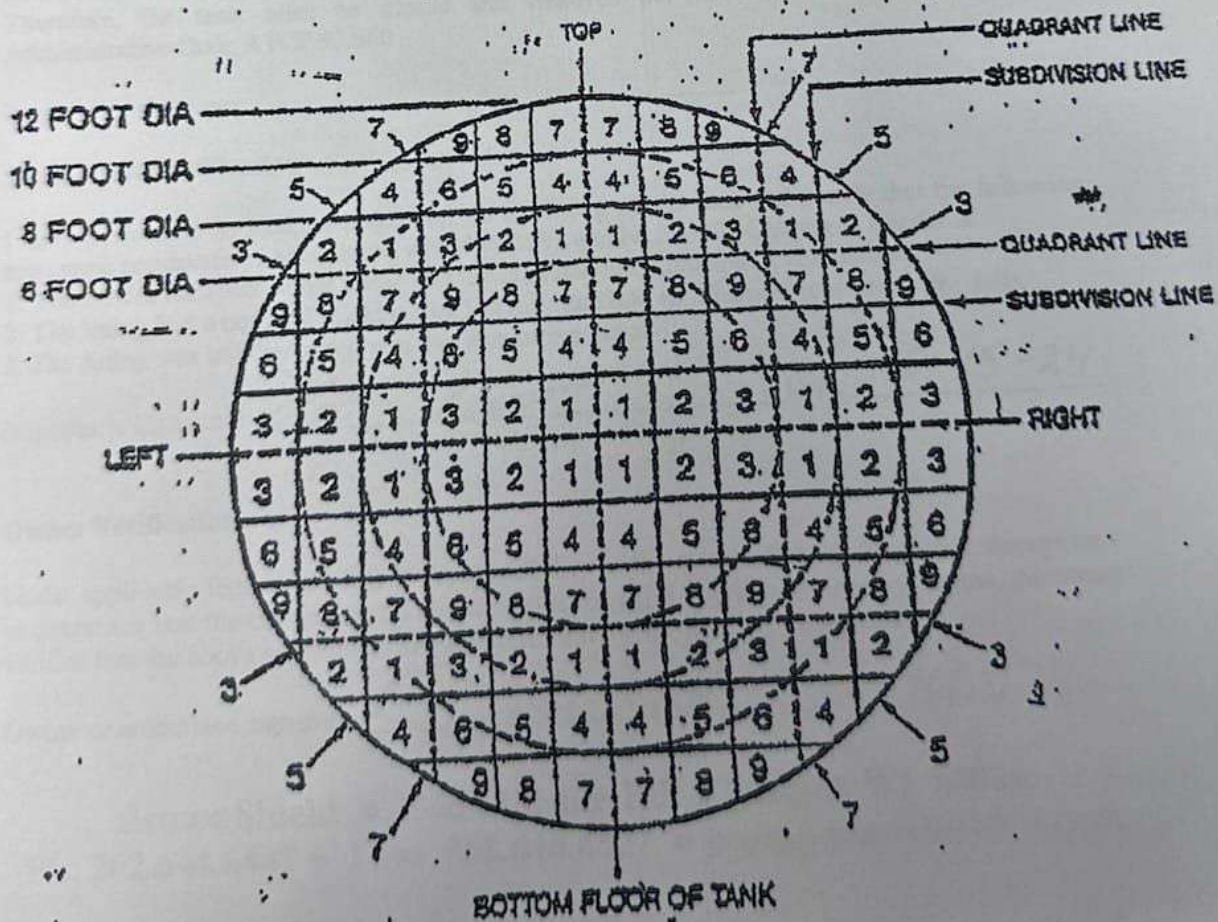
| Design Thk. | 95 | % of Design Thk. |

Tank Length 24

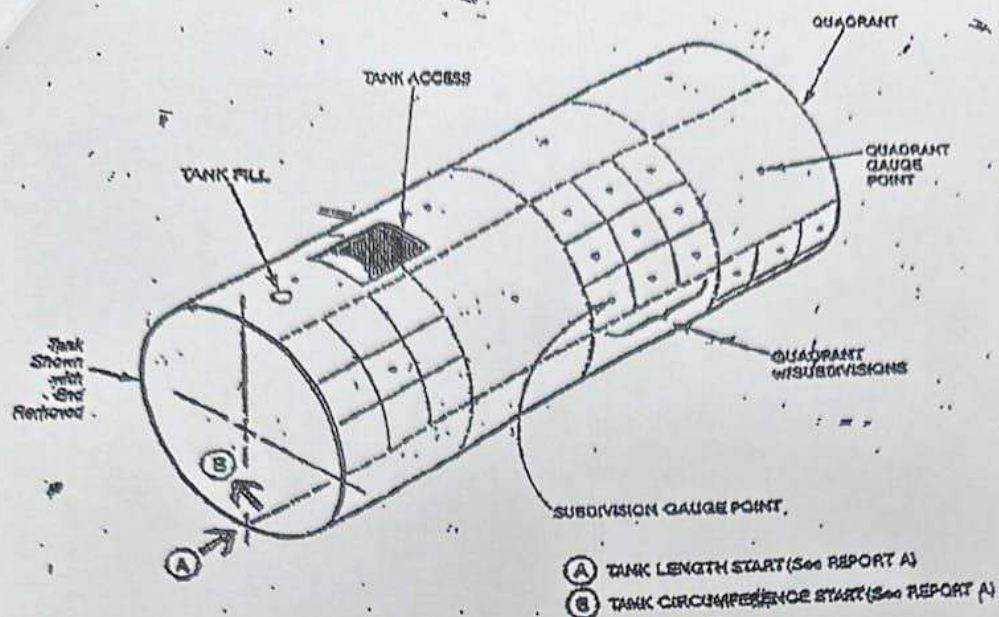
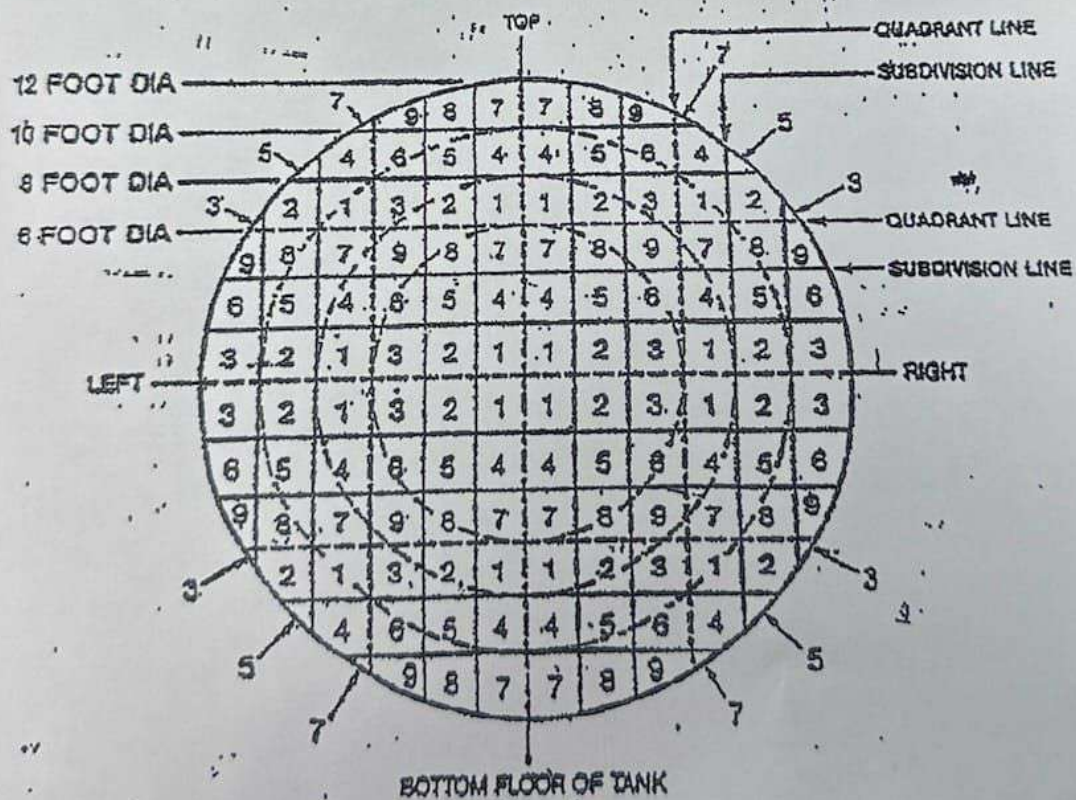
$\times 100$  92 % of Design  
Thk
